Contamination Overview Study

Highway 401 Nagle Road Interchange Study
(GWP 4059-17-00), Northumberland County

February 12, 2019

Stantec Consulting Ltd.
100-300 Hagey Boulevard
Waterloo ON N2L 0A4

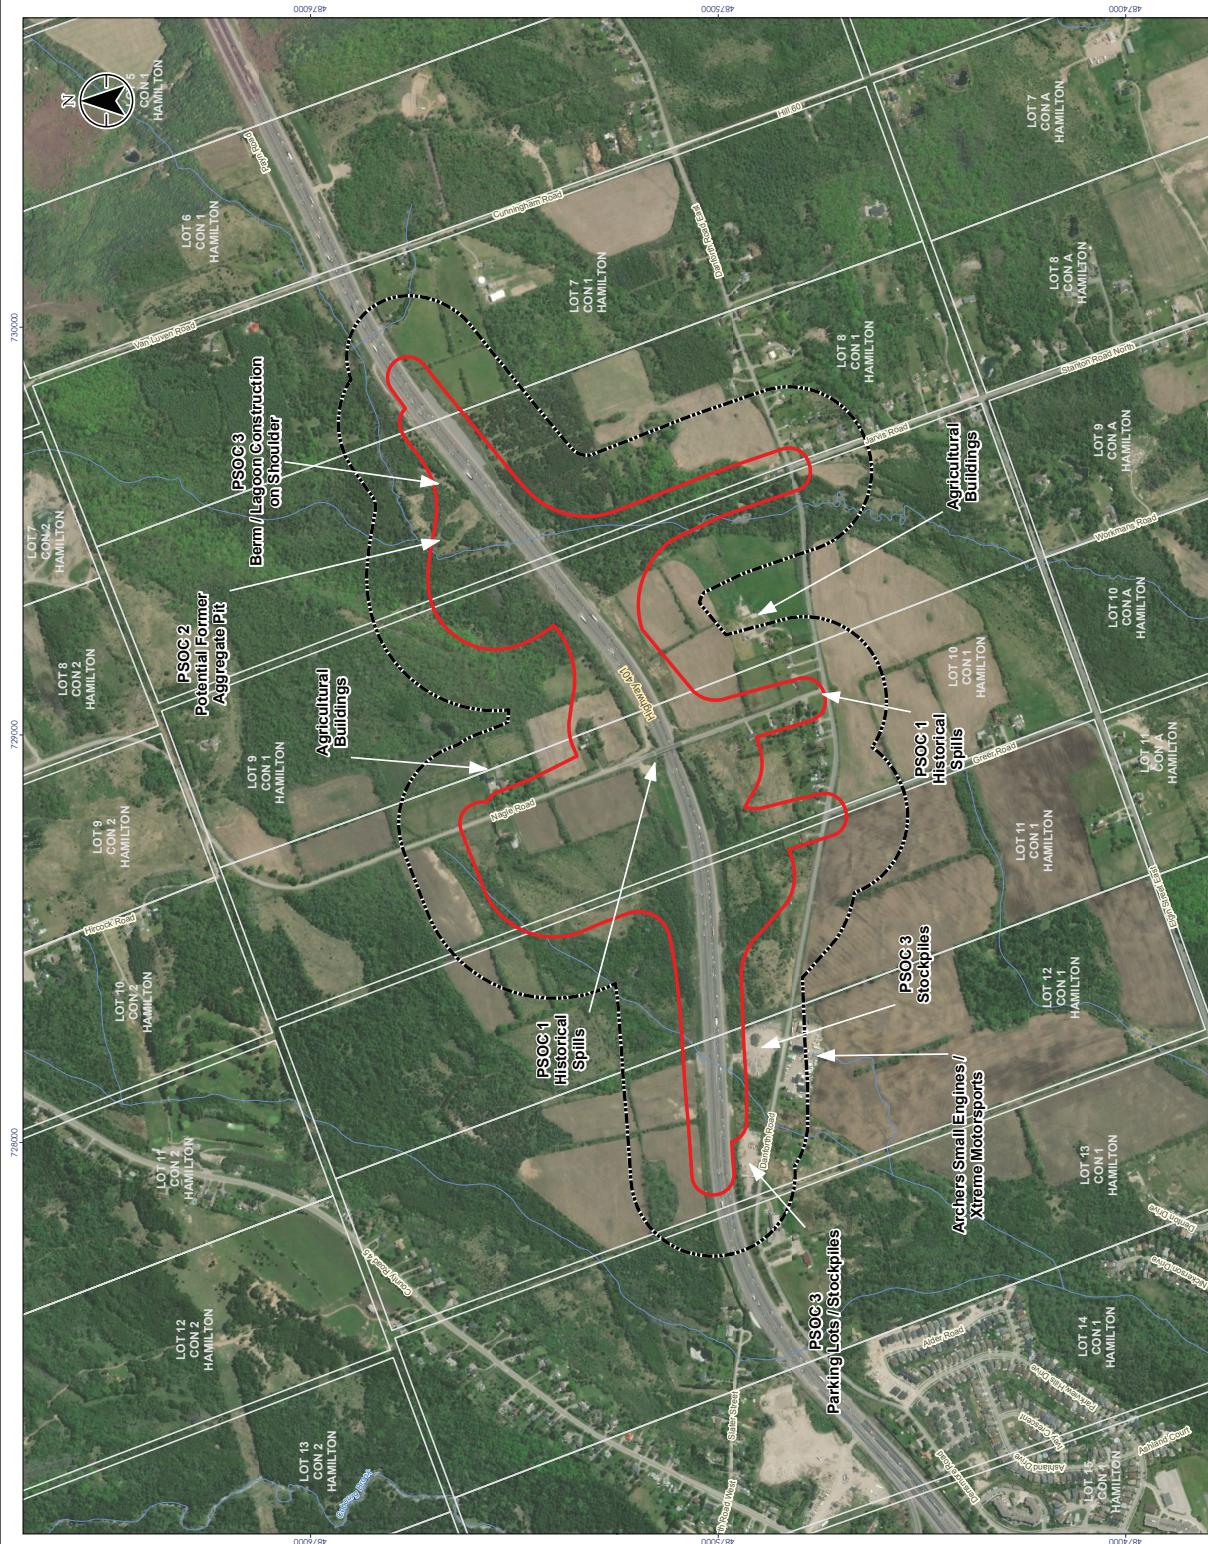
Project Location: Northumberland County
Client/Project: HIGHWAY 401 PLANNING STUDY FOR THE NAGLE ROAD INTERCHANGE (GWP 4059-17-00)
Figure No.: 2
Title: Site Plan

The Site included the proposed limits of the Nagle Road interchange alternatives, extending on either side of Highway 401 and to approximately 1.0 km to the east and west of Nagle Road, Northumberland County (**Figure 2, Appendix A**). The observed surface features included asphalt, concrete, and gravel associated with the highway. Adjacent surface features included fields, wooded areas, swamps, low-lying vegetation, and surface water drainage culverts and creeks. Photographs of the Site and surrounding area are provided in **Appendix C**.

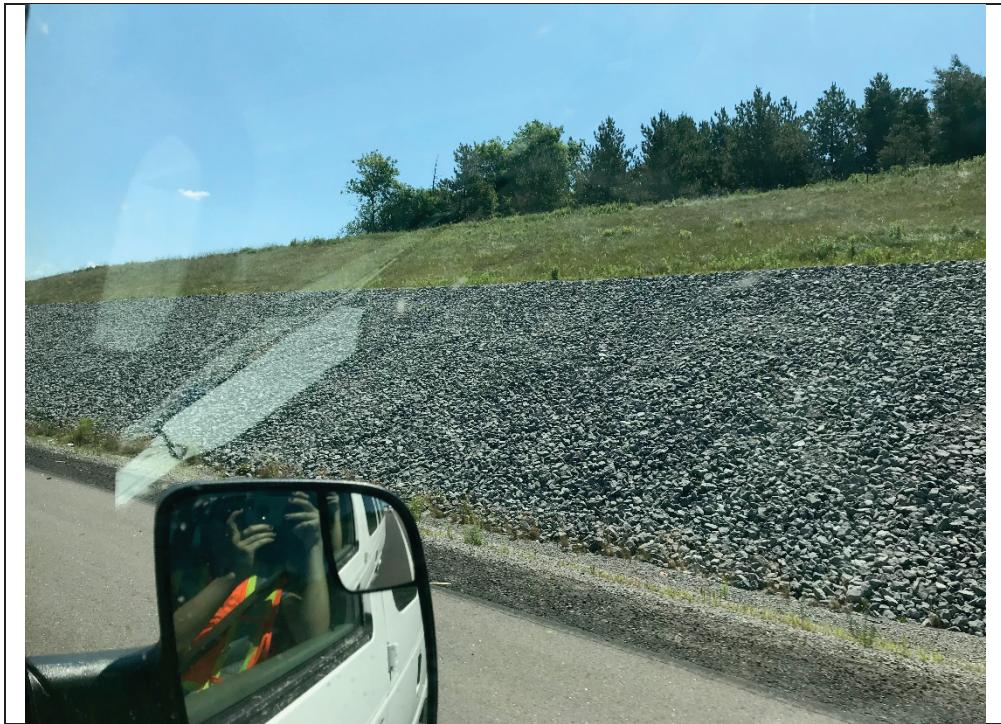
Photo 3 Stone berm, south side of Highway 401, Lot 8 Concession 1 Hamilton Twp.

- **PSOC 3** – Fill of unknown quality at various locations on the Site. At the time of the Site visit, bermed areas were observed on either side of Highway 401 and two adjacent properties had stockpiles that suggest that filling activities may have extended onto the Site. The environmental quality of this imported fill, in addition to any other fill imported for the purposes of road construction, is unknown. The potential for this PSOC to have impacted site soil or groundwater quality is considered to be high.

- Soil and groundwater that will be disturbed during construction should be sampled and analyzed for metals and inorganics (including electrical conductivity and SAR), PAHs, PHCs and VOCs. The selection of soil for analysis should take into consideration the presence of anthropogenic substances such as debris/waste, and PHC, solvent, or other unusual odours or staining.

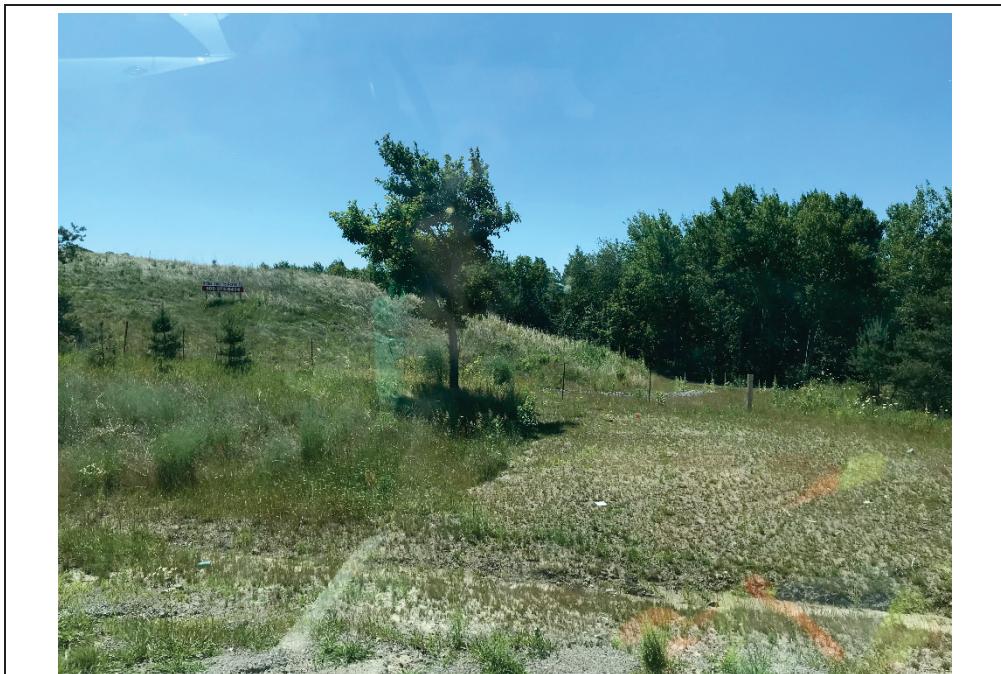
Photo 4 Berm and field just west of Cunningham Road, generally representative of the areas surrounding Highway 401, located south of Highway 401 at Lot 7, Concession 1 – Hamilton Twp.

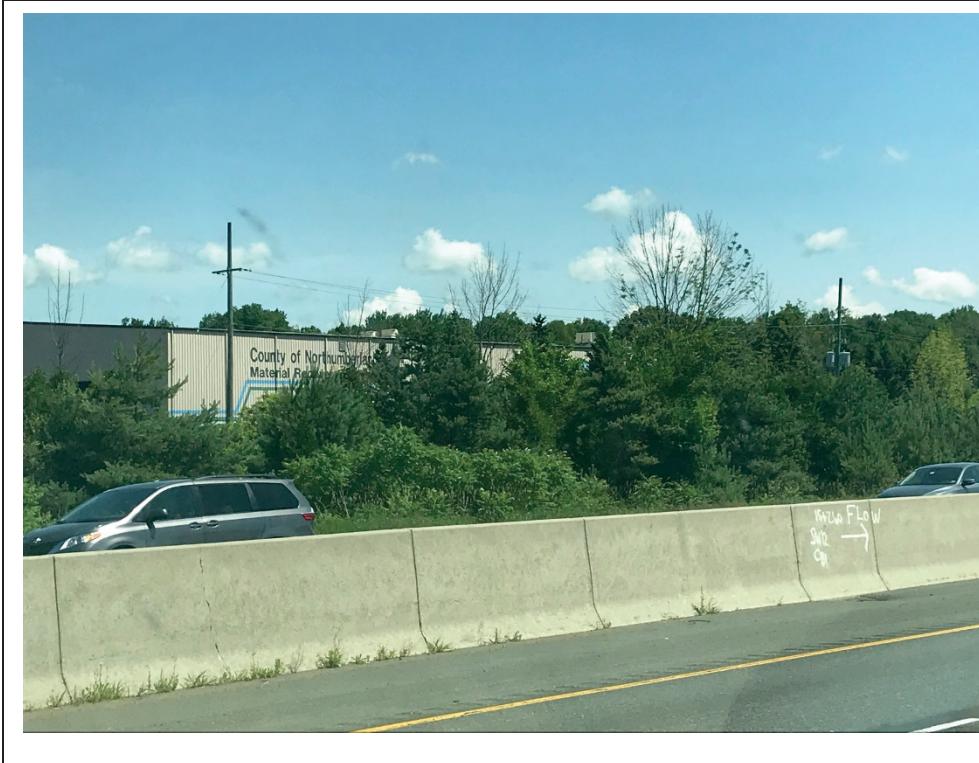
Photo 6 Example of pole-mounted transformer along Highway 401.
