## **Contamination Overview Study**

Highway 401 Planning Study from Cobourg  
to Colborne (GWP 4060-11-00)

February 27, 2019

Project No.: 165001090

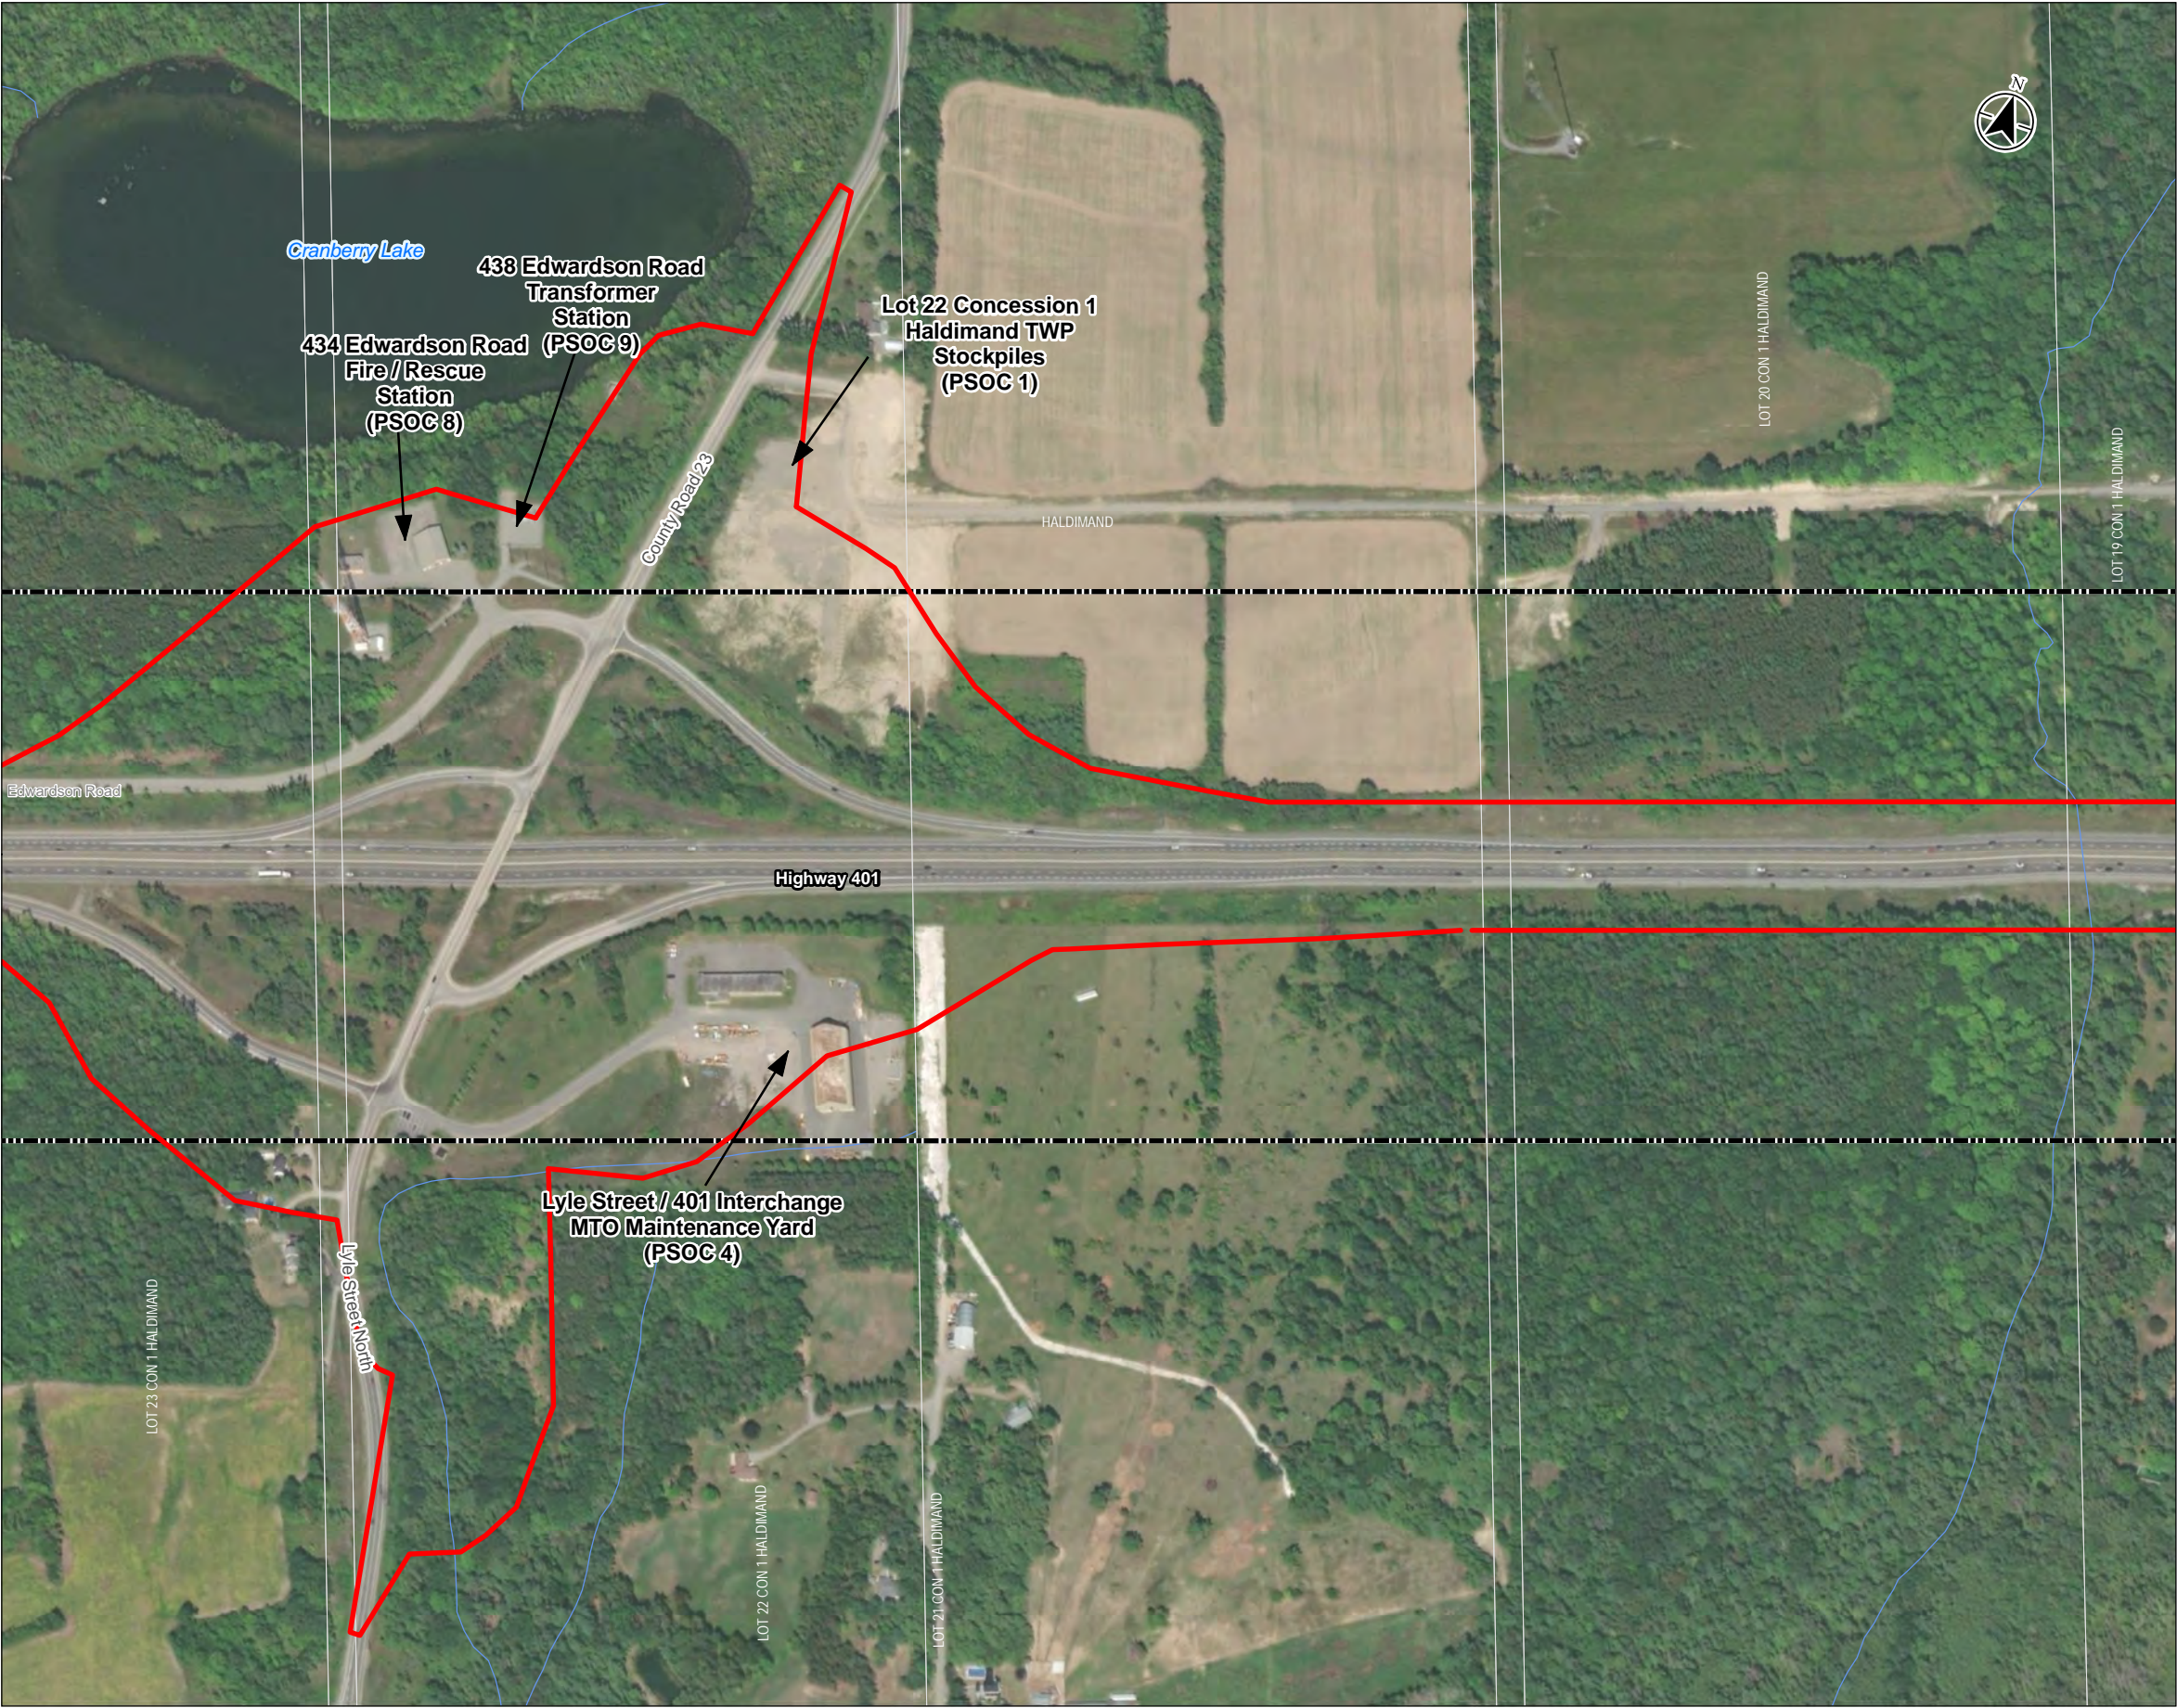
Title  
Site Plan Detail 7

The County of Northumberland Material Recovery Facility was observed at 280 Edwardson Road during the site visit (see **Figure 3-7, Appendix A**). It appeared to be an operational facility, with visible transport trucks on-site. Waste processing operations at this adjacent property were considered to represent a PSOC (**PSOC 3**).

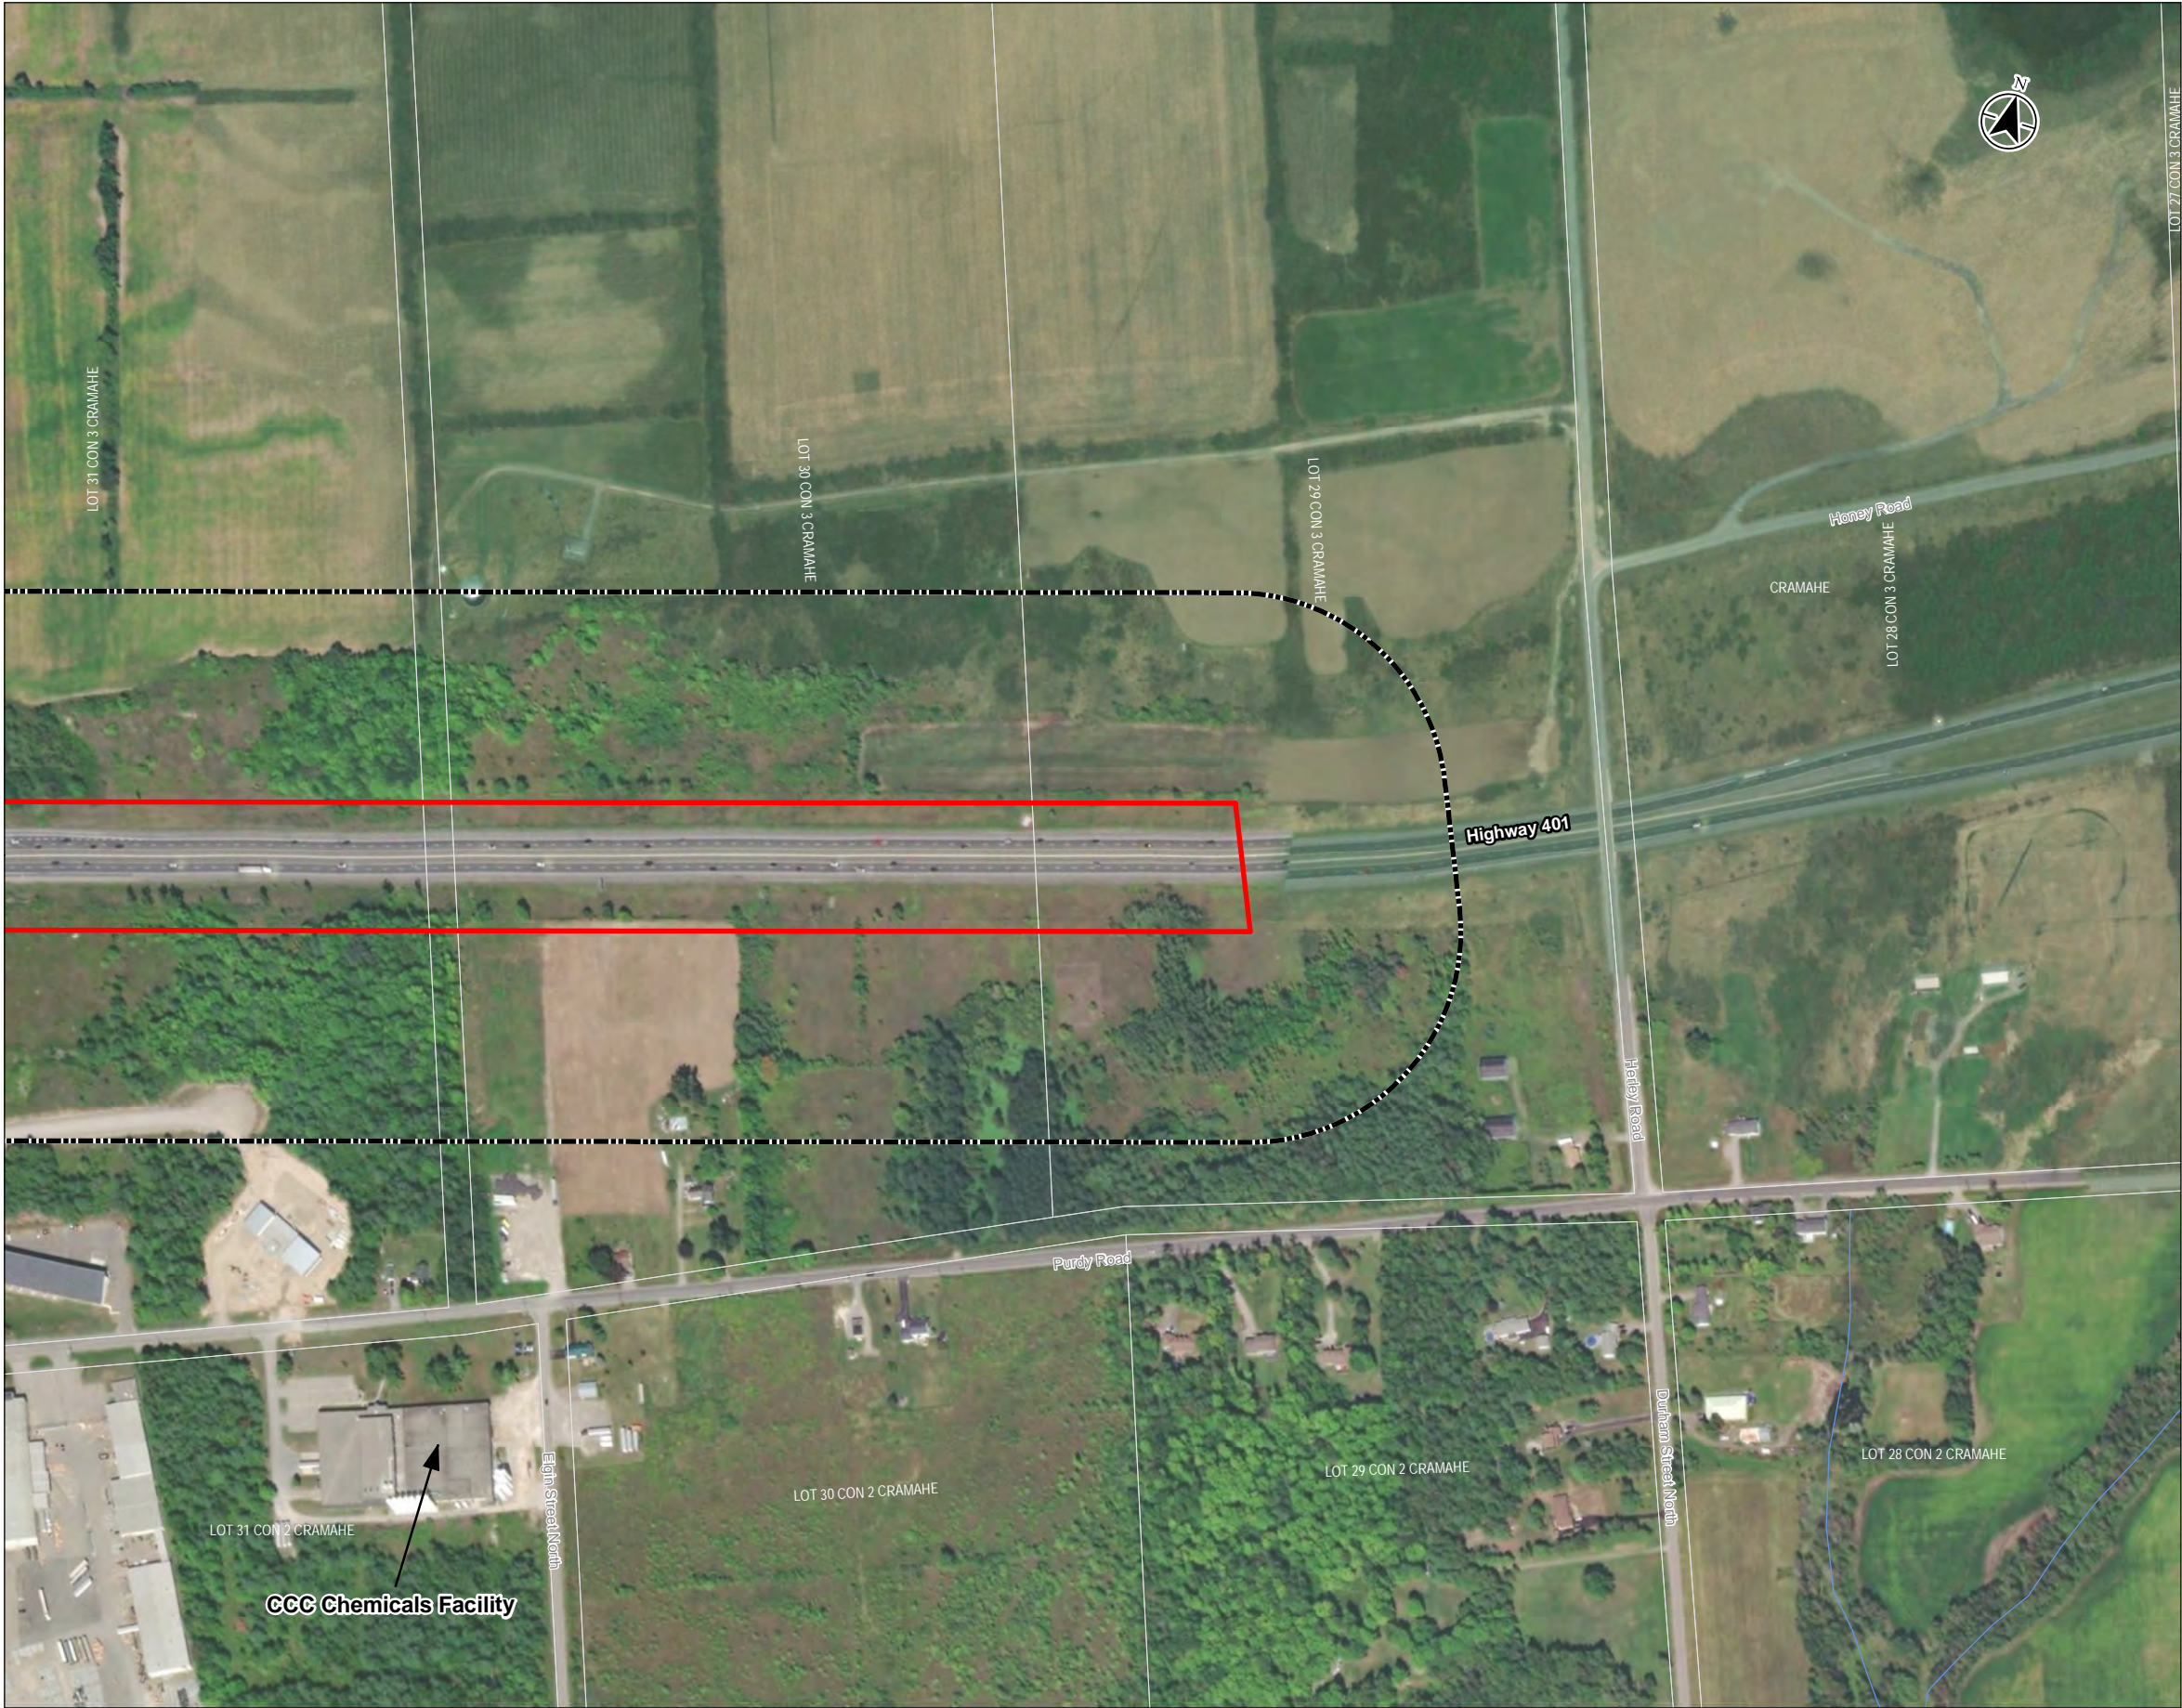
Figure No.:  
3 - 15

- **PSOC 5** – Gary Steacy Dismantling Ltd., 176 County Road 25 (**Figure 3-15, Appendix A**). This active waste receiver and generator was also approved to manage PCBs and has been active since approximately 2007 (as observed in aerial photographs). This property is situated within the northwestern portion of the Percy Street interchange and is in the inferred upgradient direction relative to the Highway 401 alignment. Based on the nature of site activities and location within the Site, this PSOC is anticipated to represent a high concern to the Site.

- **PSOC 6** – Northumberland Waste Transfer, 32 Industrial Park Road North (**Figure 3-15, Appendix A**). At the time of the Site visit, an active waste transfer station was observed at this property for non-hazardous wastes. Development at this property was observed in aerial photographs from 2009. This property is situated within the southeastern portion of the Percy Street interchange at Highway 401. Although this waste facility is partially situated within the Site, based on the nature of the wastes, the limited timeframe of operation, and the temporary nature of waste storage, the

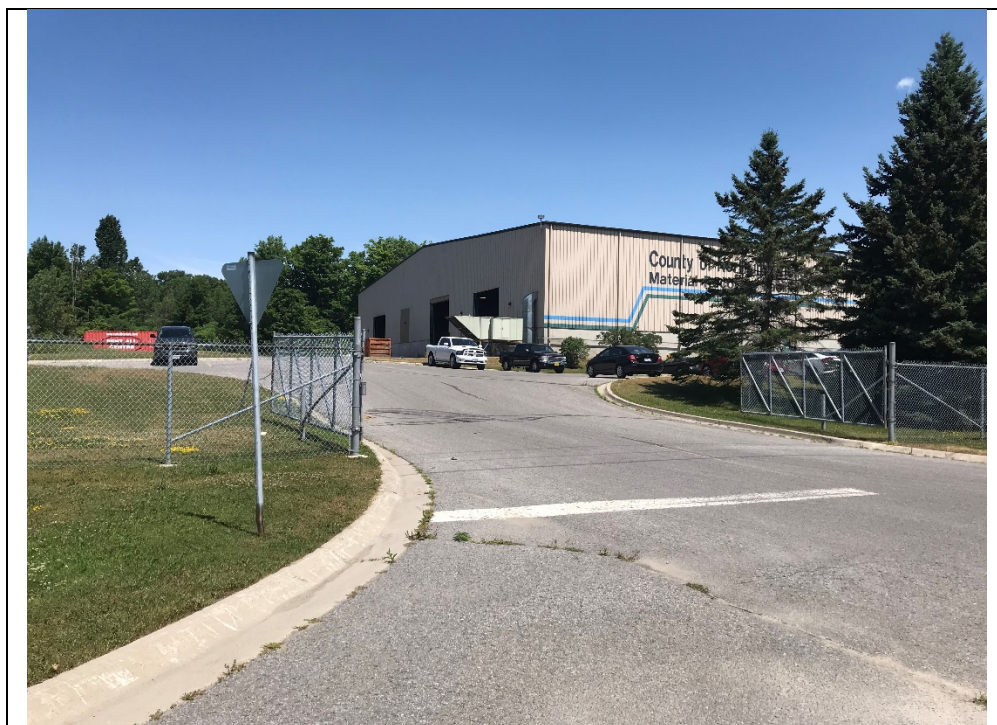
Photo 1 County of Northumberland Material Recovery Facility, 280 Edwardson Road – PSOC 3

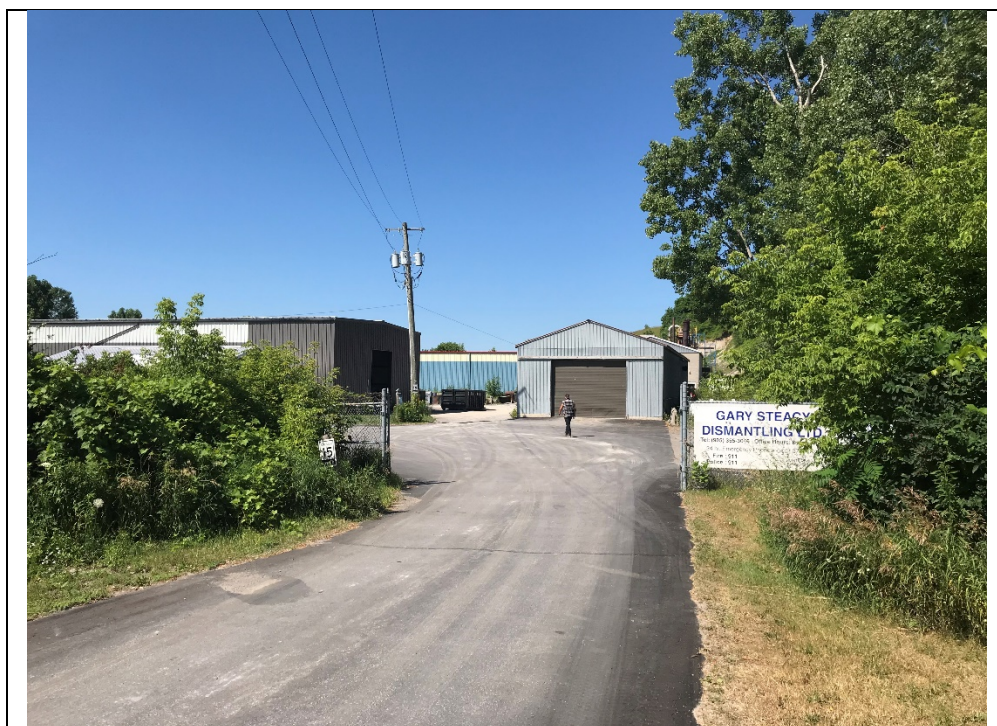
Gary Steacy Dismantling Ltd is located at 176 County Road 25 (**Figure 3-15, Appendix A**). During the site visit, this property was observed to be operational. Several trailers and dumpsters were observed on-site for storage or transportation of waste. Boiler pipes and/ or smokestacks were also visible from the roadway. Given that this is an operational waste management and disposal facility, it is considered a PSOC (**PSOC 5**).

Photo 2 Gary Steacy Dismantling Ltd., 176 County Road 25 – PSOC 5

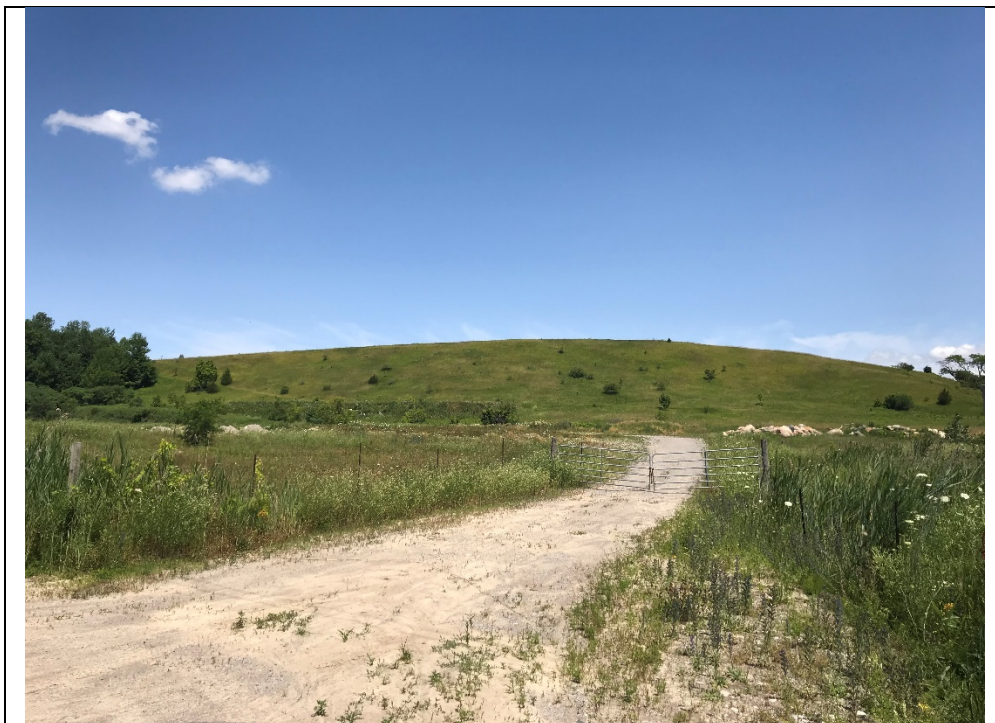
Photo 3 Gravel and rock stockpiles, North of Highway 401 on Lot 32, Concession 2, Haldimand

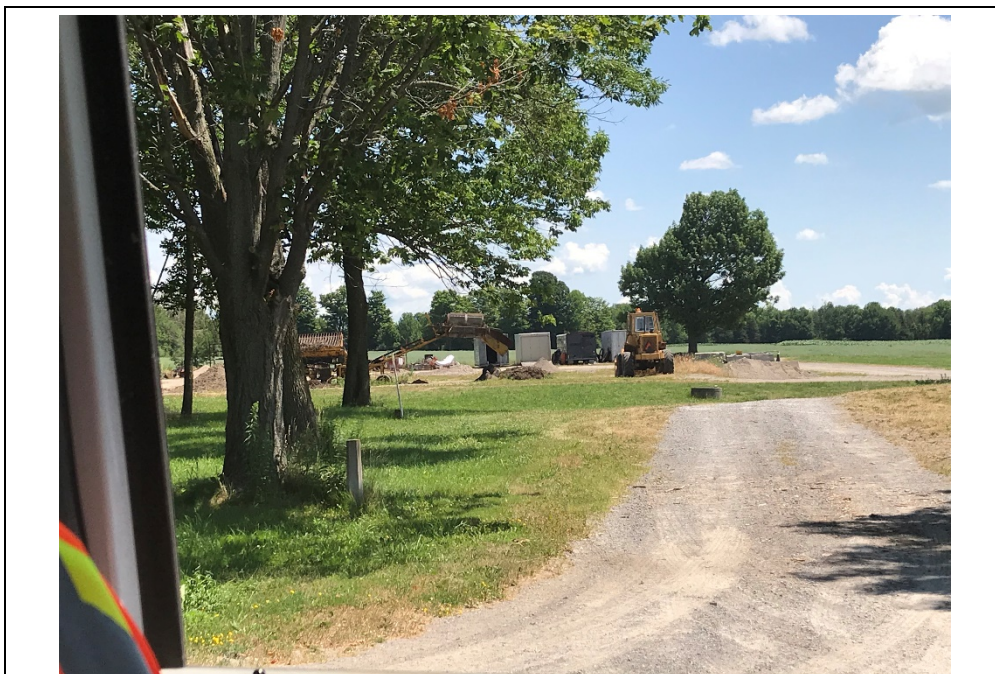
During the windshield survey, bermed areas were observed on either side of Highway 401 along the length of the Site. Additionally, multiple stockpiles were observed at different locations on agricultural properties within and adjacent to the Site and within the Study Area (north of Highway 401 on Lot 22, Concession 1, Haldimand Twp., Lot 32, Concession 2, Haldimand Twp., and cultivated field north of Highway 401 on Lot 1, Concession 1, Haldimand Twp.). Other stockpiles were noted on adjacent agricultural properties to the Site, but outside of the Study Area (100 Gully Road). The stockpiles have

Photo 4 Stockpiles on property, 100 Gully Road

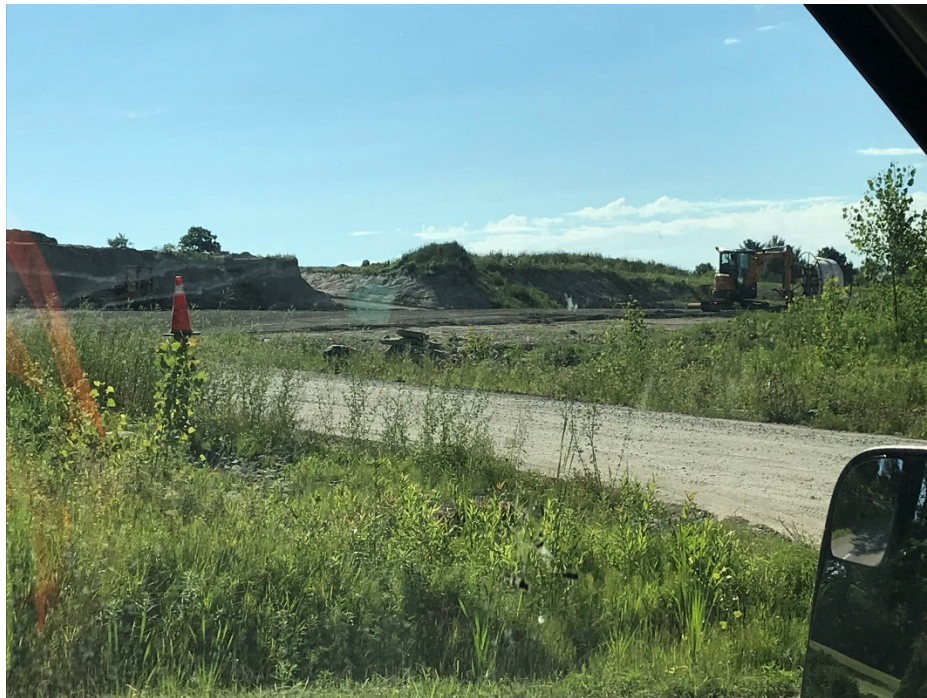
been identified on **Figures 3-5, 3-6, 3-8, and 3-14 (Appendix A)**. Most of these stockpiles were beyond the site boundary; however, the stockpiles observed to the northeast of the Lyle Street North/County Road 23 interchange (**Figure 3-8, Appendix A**) were within the Site and represent a PSOC (**PSOC 1**).

Photo 5 Stockpiles and disturbed earth, Northeast corner of Lyle Street/ County Road 23

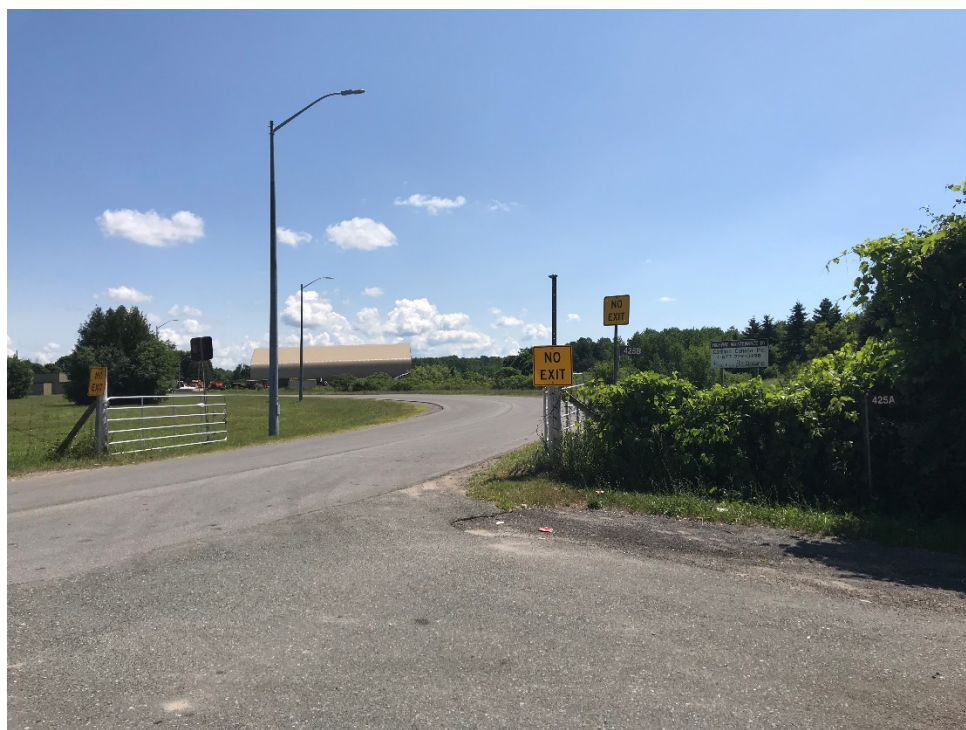
A MTO maintenance yard was observed at the southeastern corner of the Lyle Street/County Road 23 Interchange along Highway 401 (**Figure 3-8, Appendix A**), and appeared to be operational at the time of the site visit. Stockpiles of gravel were observed on this property. Fueling and likely storage of deicing salt at this facility represent a PSOC (**PSOC 4**).

No storage tanks were observed on the Site; however, records exist for a liquid fuel storage tank at the MTO Maintenance Yard southeast of the Lyle Street interchange (**PSOC 4**), and previous reports confirmed the presence of ASTs and USTs at this property.

Photo 6 MTO Maintenance Yard, Southeast corner of Lyle Street and Highway 401 Interchange – PSOC 4

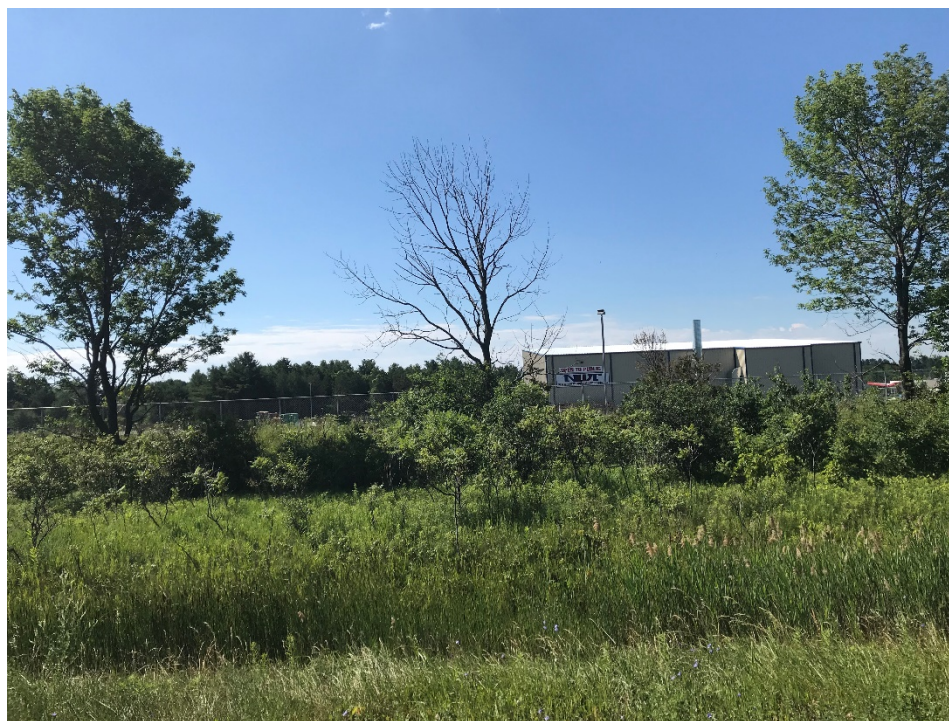
Northumberland Waste Transfer was observed from Highway 401 at 32 Industrial Park Road North, to the southeast of the County Road 25 interchange (**Figure 3-15, Appendix A**). Transport trucks and other large equipment were observed on the property. The records review indicated that this transfer station accepts non-hazardous waste including construction and demolition waste, household and yard waste,

Photo 7 Northumberland Waste Transfer, 32 Industrial Park Road North – PSOC 6

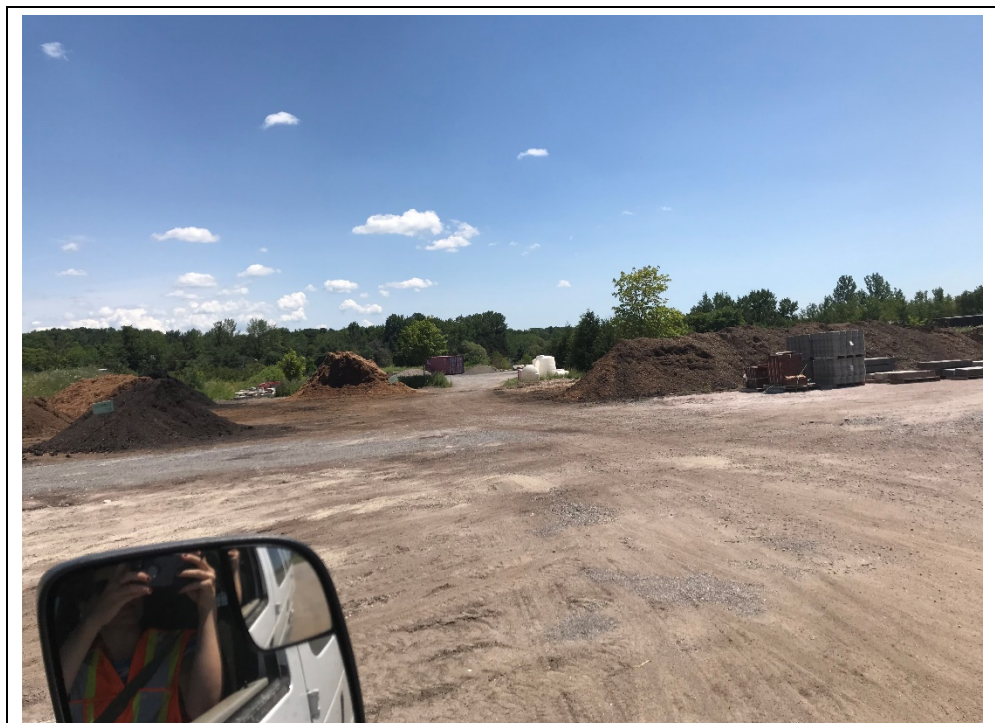
Rock Ridges Landscaping is present at 10173 Danforth Road East (**Figure 3-5, Appendix A**), and multiple piles of landscaping mulches and soil, as well as a few plastic storage containers, were observed on the property that appeared to be empty. The stockpiled materials were beyond the site boundary, and it did not appear that bulk storage of fuels or pesticides occurred at this location; consequently, it was not considered to represent a PSOC.

Photo 8 Rock Ridges Landscaping, 10173 Danforth Road East

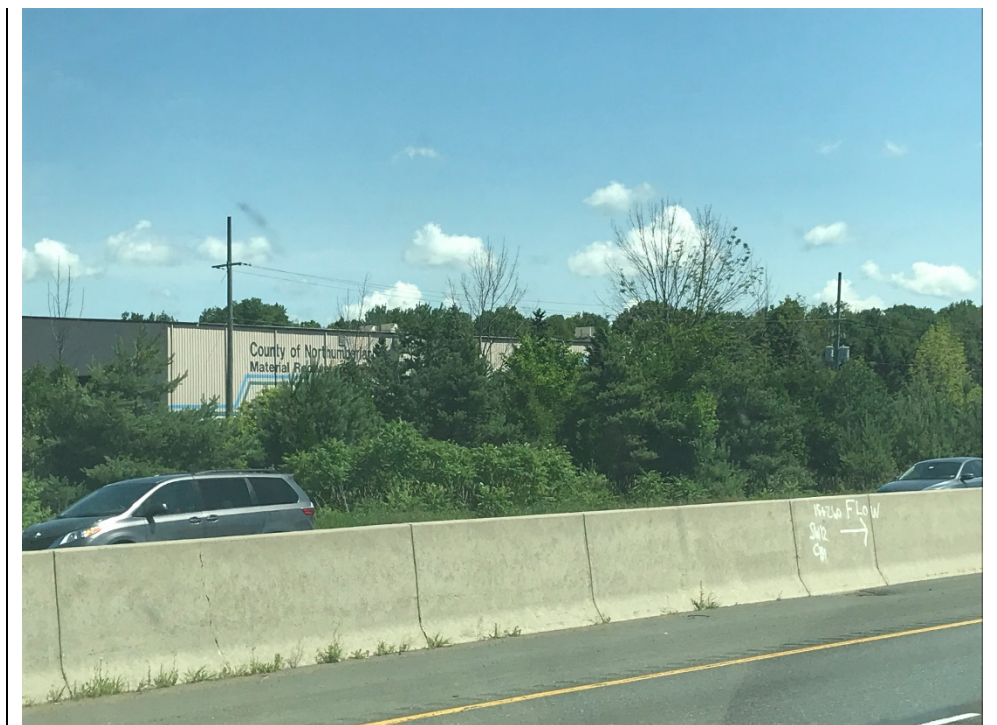
Photo 9 Example of pole-mounted transformer along Highway 401.
